DEPARTMENT OF TRANSPORTATION

Quality Assurance and Source Inspection

Contract #: 04-0120F4Cty: SF/ALA Rte: 80 PM: 13.2/13.9File #: 1.28**WELDING INSPECTION REPORT****Resident Engineer:** Casey, William**Address:** 333 Burma Road**City:** Oakland, CA 94607**Report No:** WIR-026472**Date Inspected:** 30-Sep-2011**Project Name:** SAS Superstructure**OSM Arrival Time:** 700**Prime Contractor:** American Bridge/Fluor Enterprises, a JV**OSM Departure Time:** 1530**Contractor:** American Bridge/Fluor Enterprises, a JV**Location:** Jobsite**CWI Name:** As noted below**CWI Present:** Yes No**Inspected CWI report:** Yes No N/A**Rod Oven in Use:** Yes No N/A**Electrode to specification:** Yes No N/A**Weld Procedures Followed:** Yes No N/A**Qualified Welders:** Yes No N/A**Verified Joint Fit-up:** Yes No N/A**Approved Drawings:** Yes No N/A**Approved WPS:** Yes No N/A**Delayed / Cancelled:** Yes No N/A**Bridge No:** 34-0006**Component:** SAS OBG**Summary of Items Observed:**

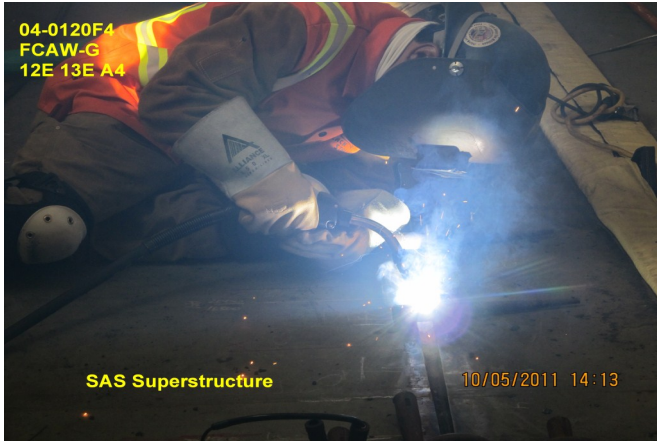
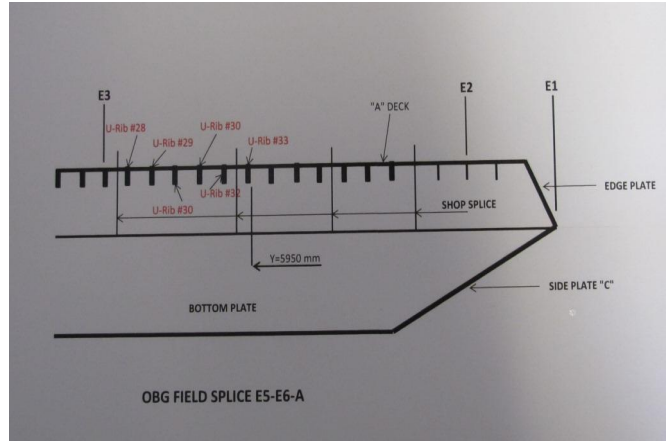
This QAI performed a Magnetic Particle Testing (MPT) of the Partial Joint Penetration (PJP) groove weld located at the closed U-rib to "A" deck shop connection between the Y coordinates 8535 mm to 10330 mm along the "A" deck field splice connection identified as 5E-6E-A at Panel Point (PP) 37. The testing was performed due to the contractor utilizing mechanical means (hydraulic jacks), with temporary attachments welded on the "A" deck in attempt to bring the field splice into an acceptable planar alignment. The Visual Testing (VT) and MPT were performed utilizing the following inspection procedures accordingly and are identified as, SE-VT-CT-D1.5-103 and SE-MT-D1.5-CT-100, Rev. 4. At the conclusion of the inspection and testing no rejectable discontinuities were noted by this QAI and appeared to comply with the contract specifications. For additional information see the MPT report identified as TL-6028 generated on this date. See map on page 3 of this report.
